**HELLENIC AIR & RAIL  
SAFETY INVESTIGATION AUTHORITY  
(HARSIA)**

**ACCIDENT INVESTIGATION INTERIM REPORT  
OF PILATUS PC-6/B2-H4 AIRPLANE  
DITCHED 2NM EAST OF HERAKLION INTERNATIONAL AIRPORT (LGIR)  
ON DECEMBER 15<sup>th</sup>, 2022**

**Accident Interim Report**

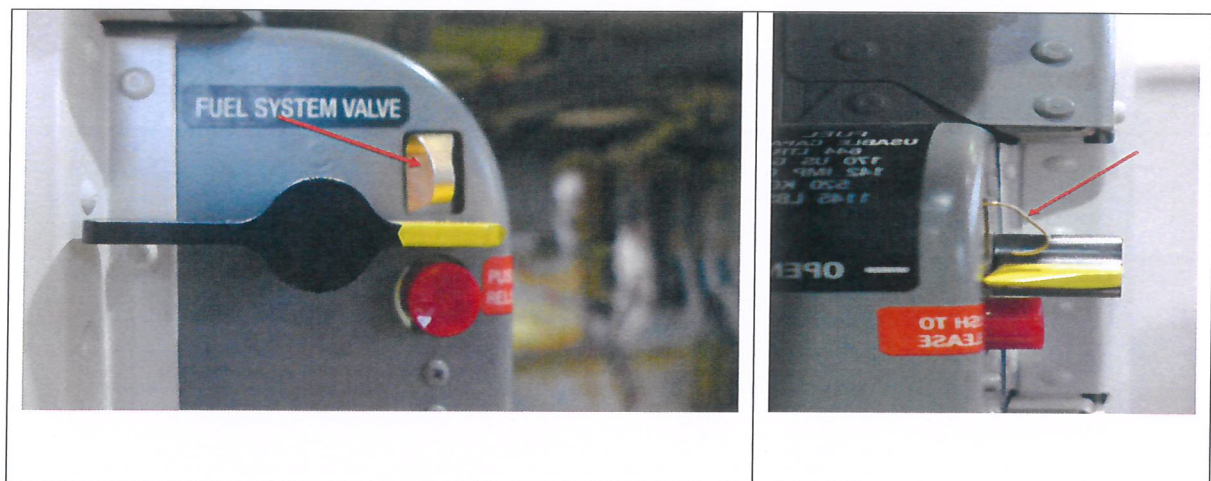
A fuel collector tank is installed in the fuselage of the aircraft which has an integrated auxiliary fuel pump. Fuel passes through a fuel shutoff valve to the aircraft engine driven pump. The valve is manually operated from the cockpit making isolation of the engine fuel supply possible in the event of an emergency but also allowing engine components to be removed without the need for fuel draining. The valve switch is in the "OPEN" position during normal engine operation. In order for the valve switch to be in the "CLOSE" position, the red button must first be pressed and then the switch must be turned to the "CLOSE" position.

**Figure 1:** Fuel System Valve Switch

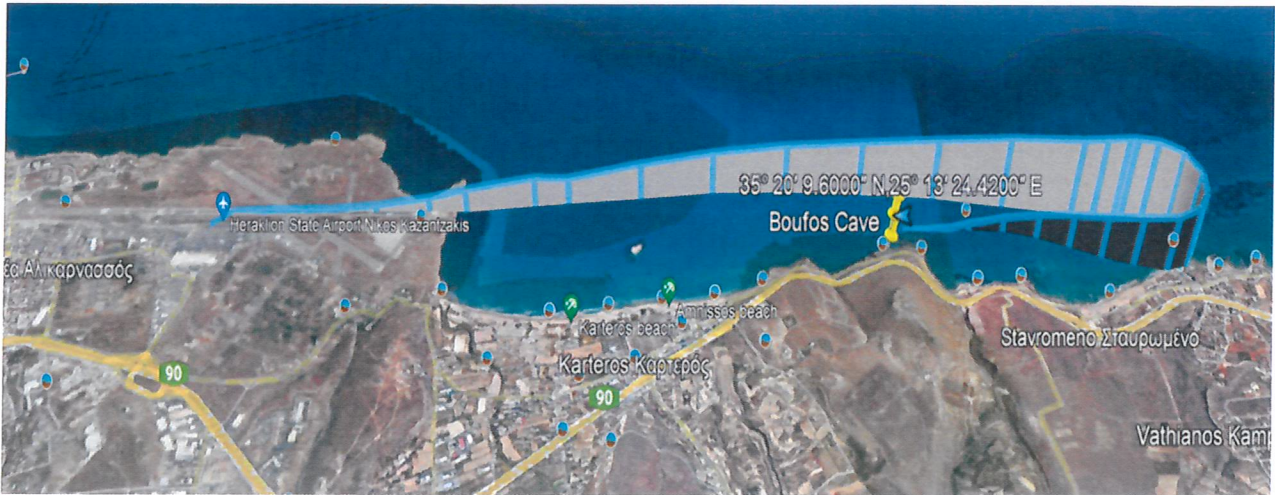
The aircraft ditched in a sea area East of Heraklion Airport and at a distance of approximately 1.65nm from the threshold of Runway 27.

Figure 8: The course of aircraft PK-SNF

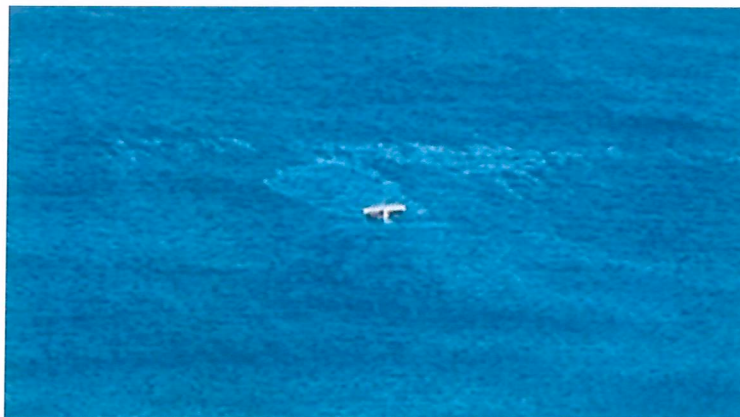
After the aircraft ditched, it remained on the sea surface for a few minutes with its front part into the sea and later it was sunk.

Figure 9: The semi-merged aircraft.

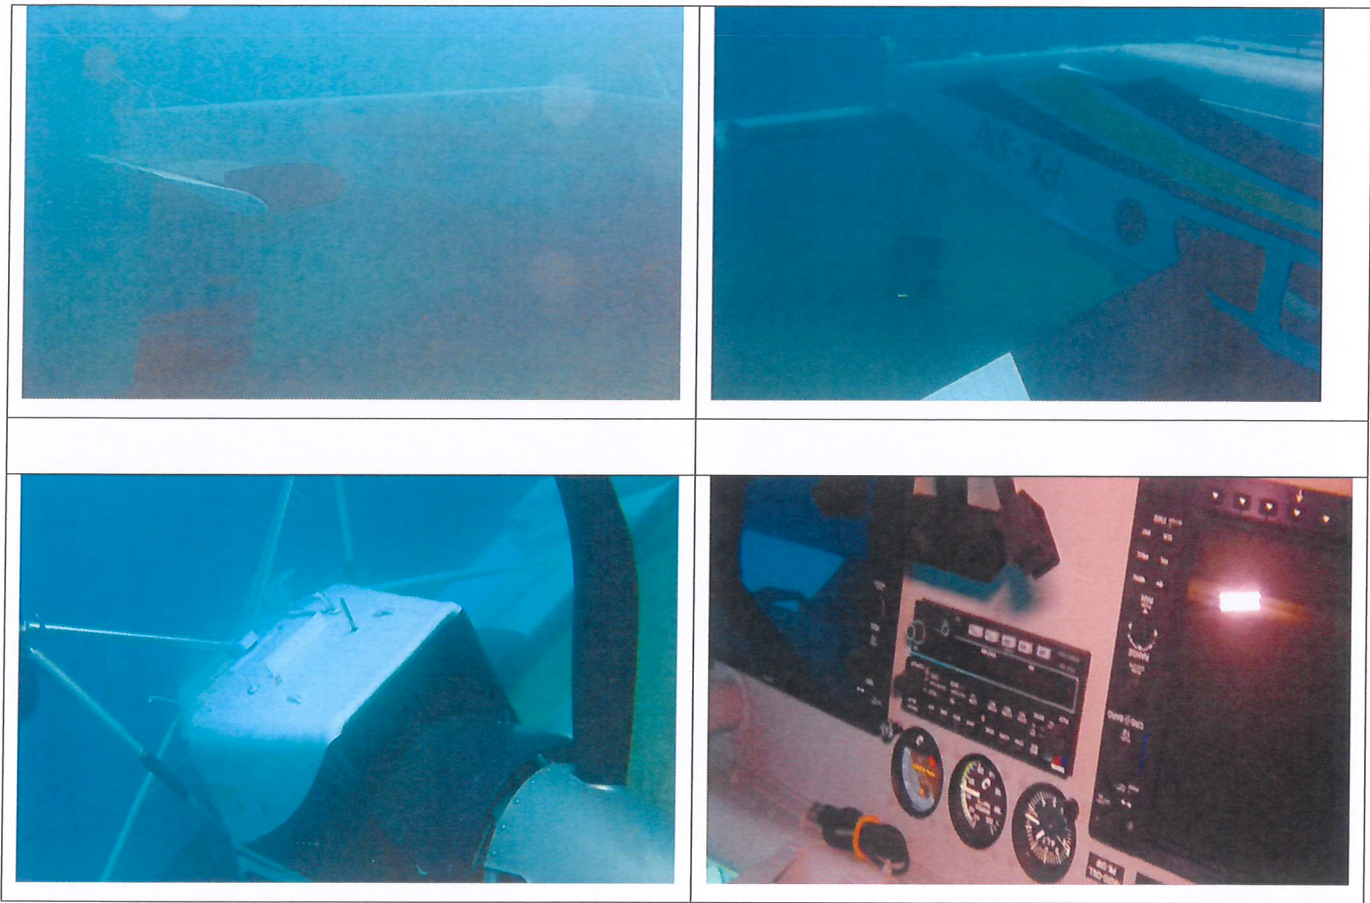
The aircraft, a few minutes after ditching, sank in the sea and remained there. The aircraft was destroyed after being severely damaged during ditching and rested at the bottom of the sea.

Photos taken by the divers show the aircraft on the seabed with its upper part touching the bottom.
