# Aviation Investigation Preliminary Report

| <b>Location:</b> | Louisville, KY | <b>Accident Number:</b> | DCA26MA024 |
| <b>Aircraft:</b> | McDonnell Douglas MD-11F | <b>Injuries:</b> | 14 Fatal, 2 Serious, 21 Minor |

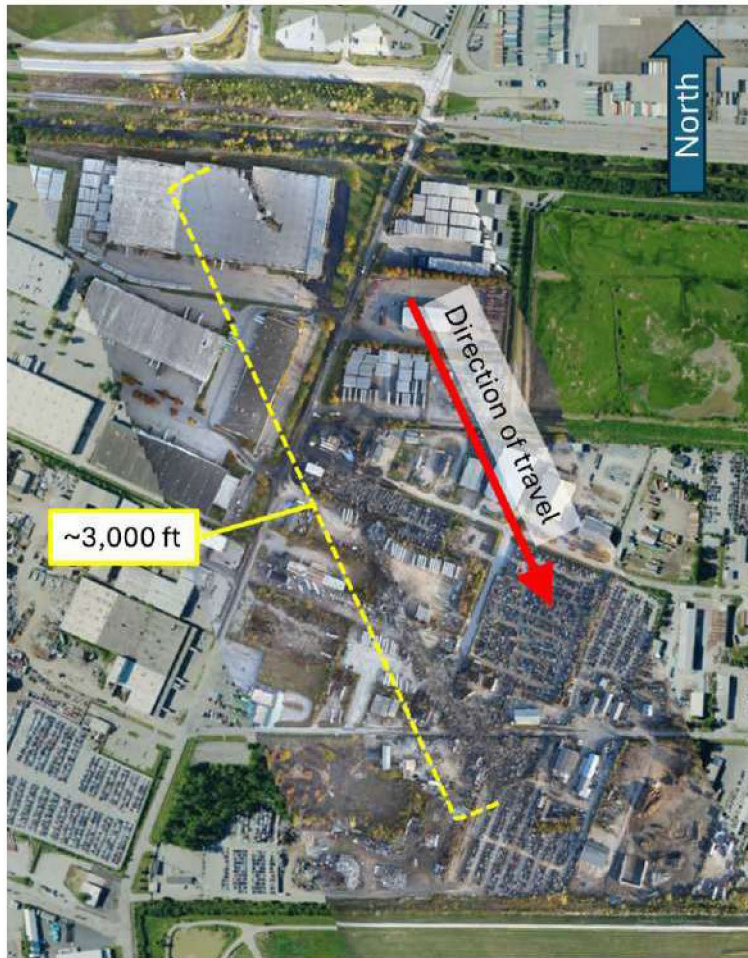
The airplane initially climbed but did not get higher than about 30 ft above ground level (agl) according to radio altitude data from the FDR. (Based on FAA-provided ADS-B data, the last data point showed 481 ft mean sea level [msl] and 100 ft agl.) The airplane cleared the blast fence beyond the end of runway 17R, but the left main landing gear impacted the roof of a UPS Supply Chain Solutions warehouse at the southern edge of the airport (see figures 2 and 3). The airplane then impacted a storage yard and two additional buildings, including a petroleum recycling facility, and was mostly consumed by fire. The wreckage area continued from the

UPS warehouse to about 3,000 ft south-southeast of it (see figure 4). The accident site debris was centered about 38° 8' 49.85" north by 85° 44' 3.86" west.

**Figure 4.** Accident site composite view created from aerial imaging overlaid on a Google Earth image. The upper end of the yellow-dashed bracket is the initial impact between the airplane landing gear and the UPS building roof.A

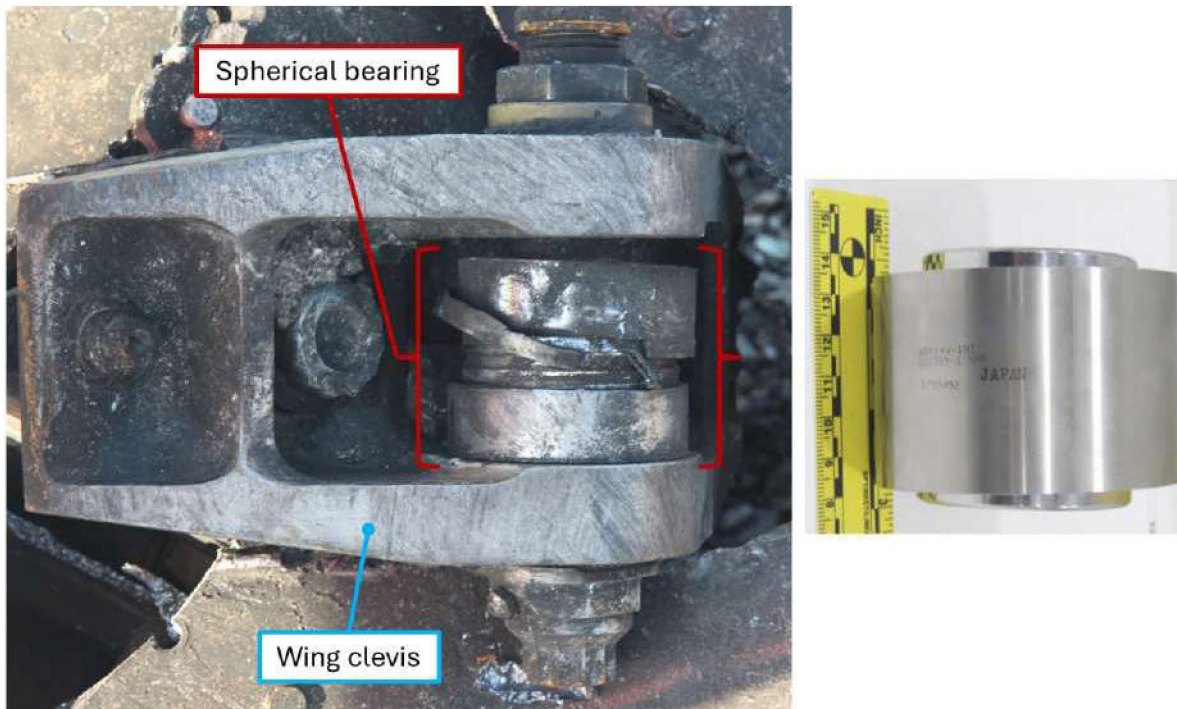
The left pylon aft mount's forward and aft lugs were both found fractured near their 2 o'clock (inboard fracture) and 9 o'clock (outboard fracture) positions when in the aft-looking-forward frame of reference (see figure 7). The fractured and separated upper portions of the forward and aft lugs were found adjacent to runway 17R. The left wing clevis, aft mount spherical bearing, and aft mount attachment hardware were found with a portion of the left wing at the accident site. The bolt, spherical bearing, and associated hardware remained attached to the wing clevis. The spherical bearing outer race had fractured circumferentially, exposing the ball element (see figure 8).

**Figure 8.** The left wing clevis, fractured spherical bearing (marked by the red brackets), and associated attachment hardware found at the accident site (left) and an exemplar spherical bearing (right).

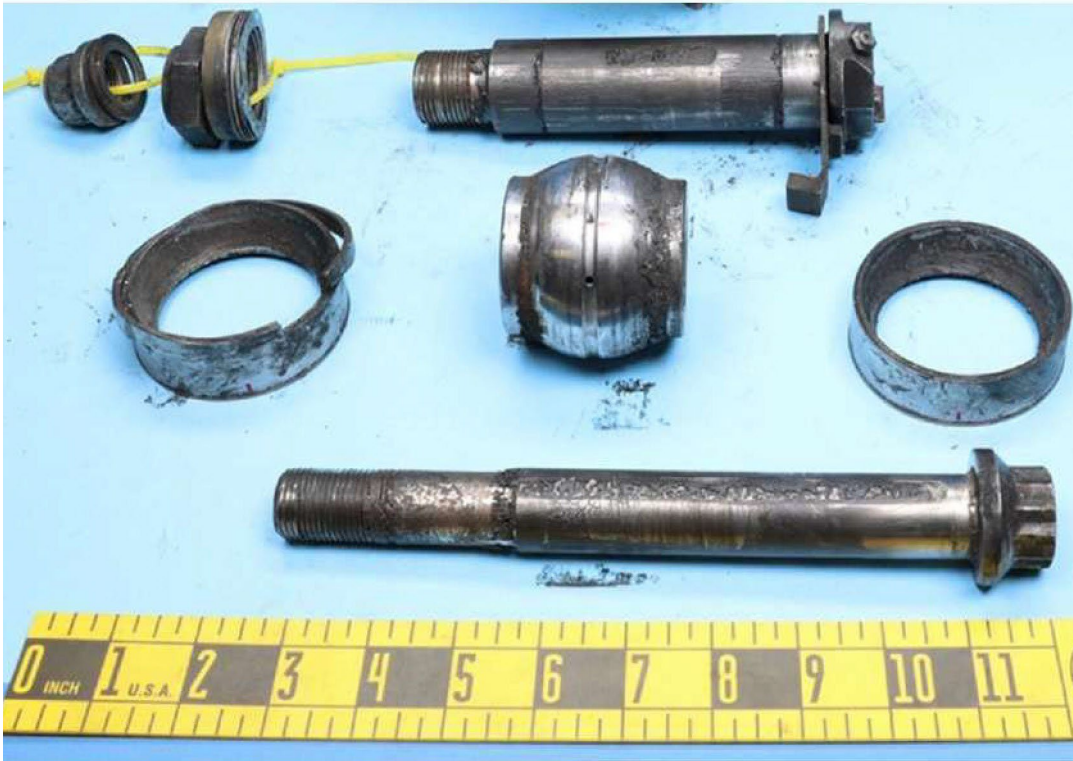
**Figure 10.** The spherical bearing and attachment hardware after removal from the left wing clevis.
