**HELLENIC AIR & RAIL  
SAFETY INVESTIGATION AUTHORITY  
(HARSIA)**

**ACCIDENT INVESTIGATION INTERIM REPORT  
OF PILATUS PC-6/B2-H4 AIRPLANE  
DITCHED 2NM EAST OF HERAKLION INTERNATIONAL AIRPORT (LGIR)  
ON DECEMBER 15<sup>th</sup>, 2022**

**Accident Interim Report**

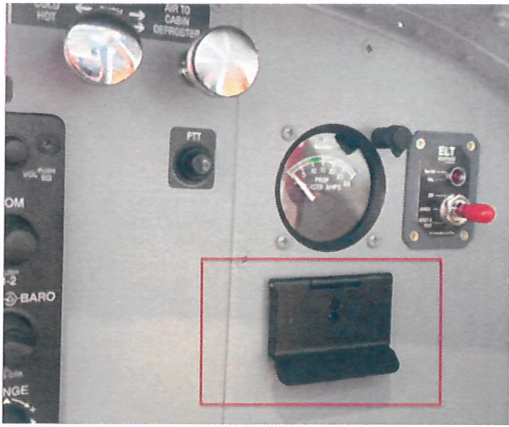
Figure 6

Divers managed to collect the memory card located on the cockpit instrument panel. Attempts were made to remove the tail section unit from the aircraft but this was not possible as access to the point where the unit was installed was impossible. Note that both memory cards store the same flight data.
