# Aviation Investigation Preliminary Report

| <b>Location:</b> | Louisville, KY | <b>Accident Number:</b> | DCA26MA024 |
| <b>Aircraft:</b> | McDonnell Douglas MD-11F | <b>Injuries:</b> | 14 Fatal, 2 Serious, 21 Minor |

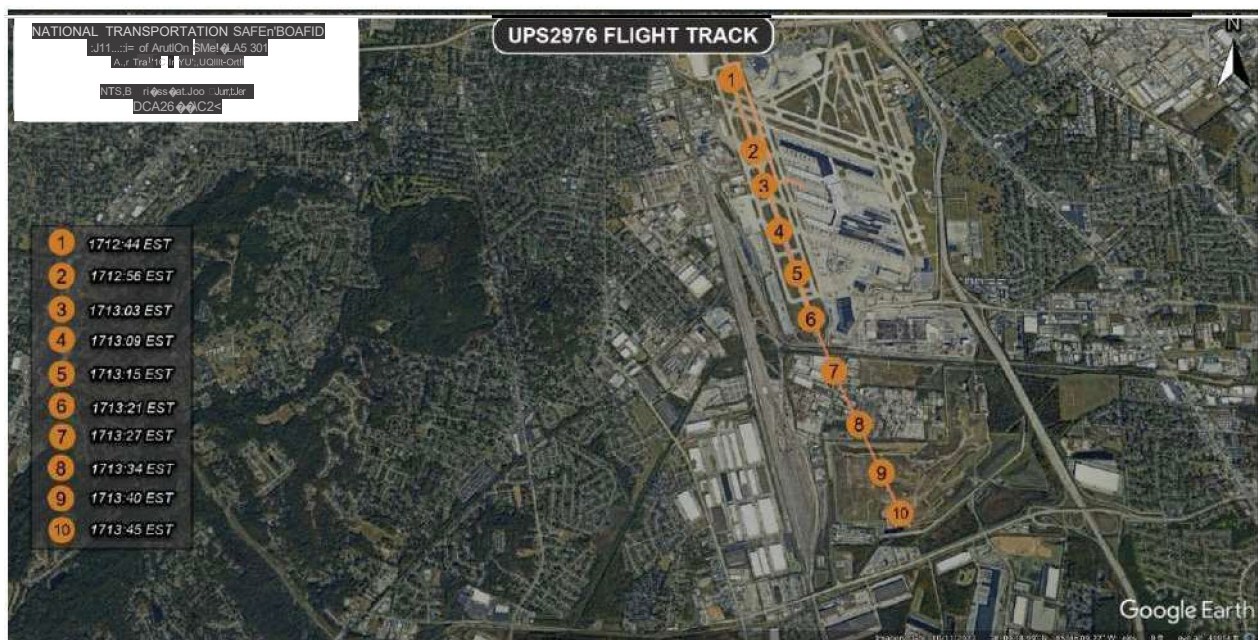
**Figure 3.** Graphic depicting the flight track of UPS flight 2976 based on ADS-8 data.

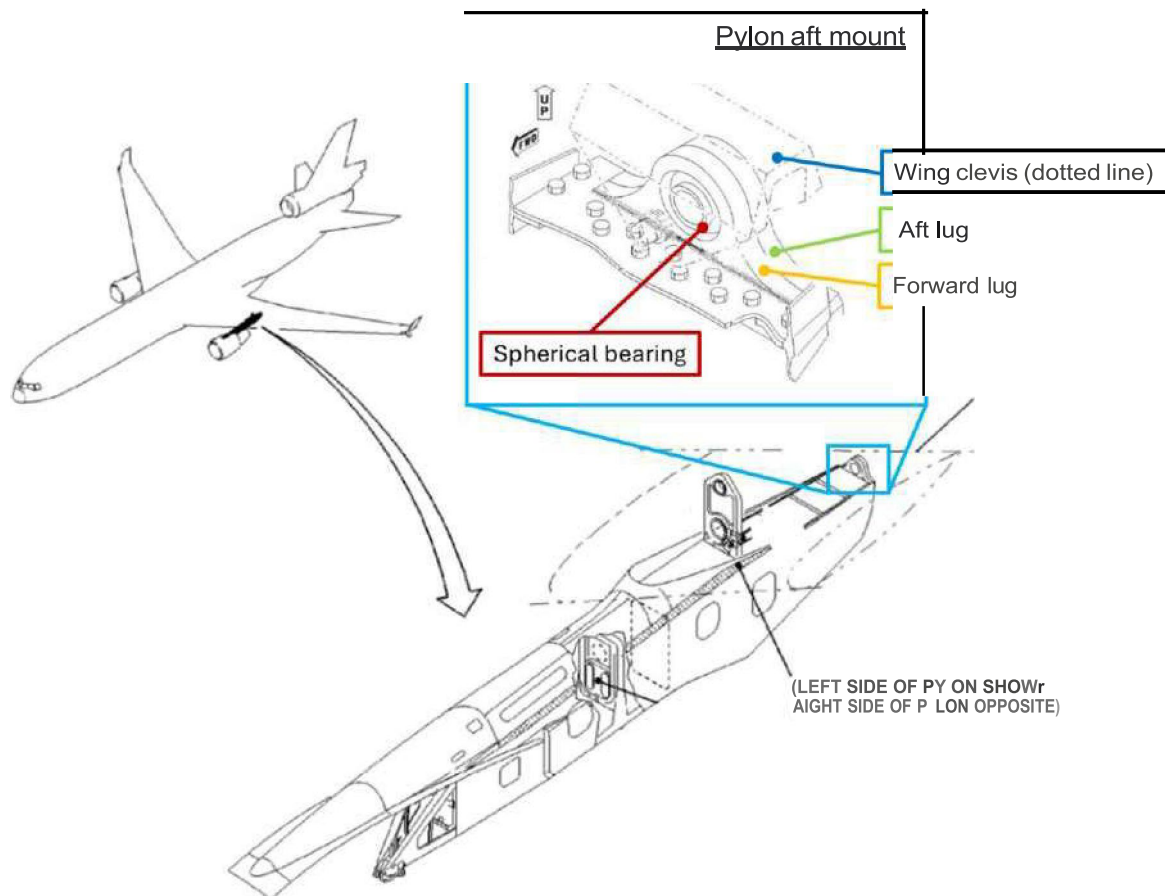
The thrust link assembly, located immediately behind the forward mount's lower spherical bearing, primarily transmits thrust loads. The pylon aft mount is an assembly composed of two independent fittings bolted together, with lugs (forward lug and aft lug) that house a single spherical bearing (see figures 5 and 6). For this report, references to the pylon aft mount spherical bearing includes both the bearing's ball element (sphere) and its outer race. A clevis

**Figure 5.** The pylon-to-wing mount diagram, with the inset image showing details of the pylon aft mount connection to the wing clevis. (Source: Boeing, edited by NTSB)
